INDIAN LAKE DAM

**NDI ID NO. PA-01041
DER ID NO. 40-143**

PHASE I INSPECTION REPORT NATIONAL DAM INSPECTION PROGRAM

PHASE I. INSPECTION REPORT
NATIONAL DAM INSPECTION PROGRAM
BRIEF ASSESSMENT OF GENERAL CONDITION

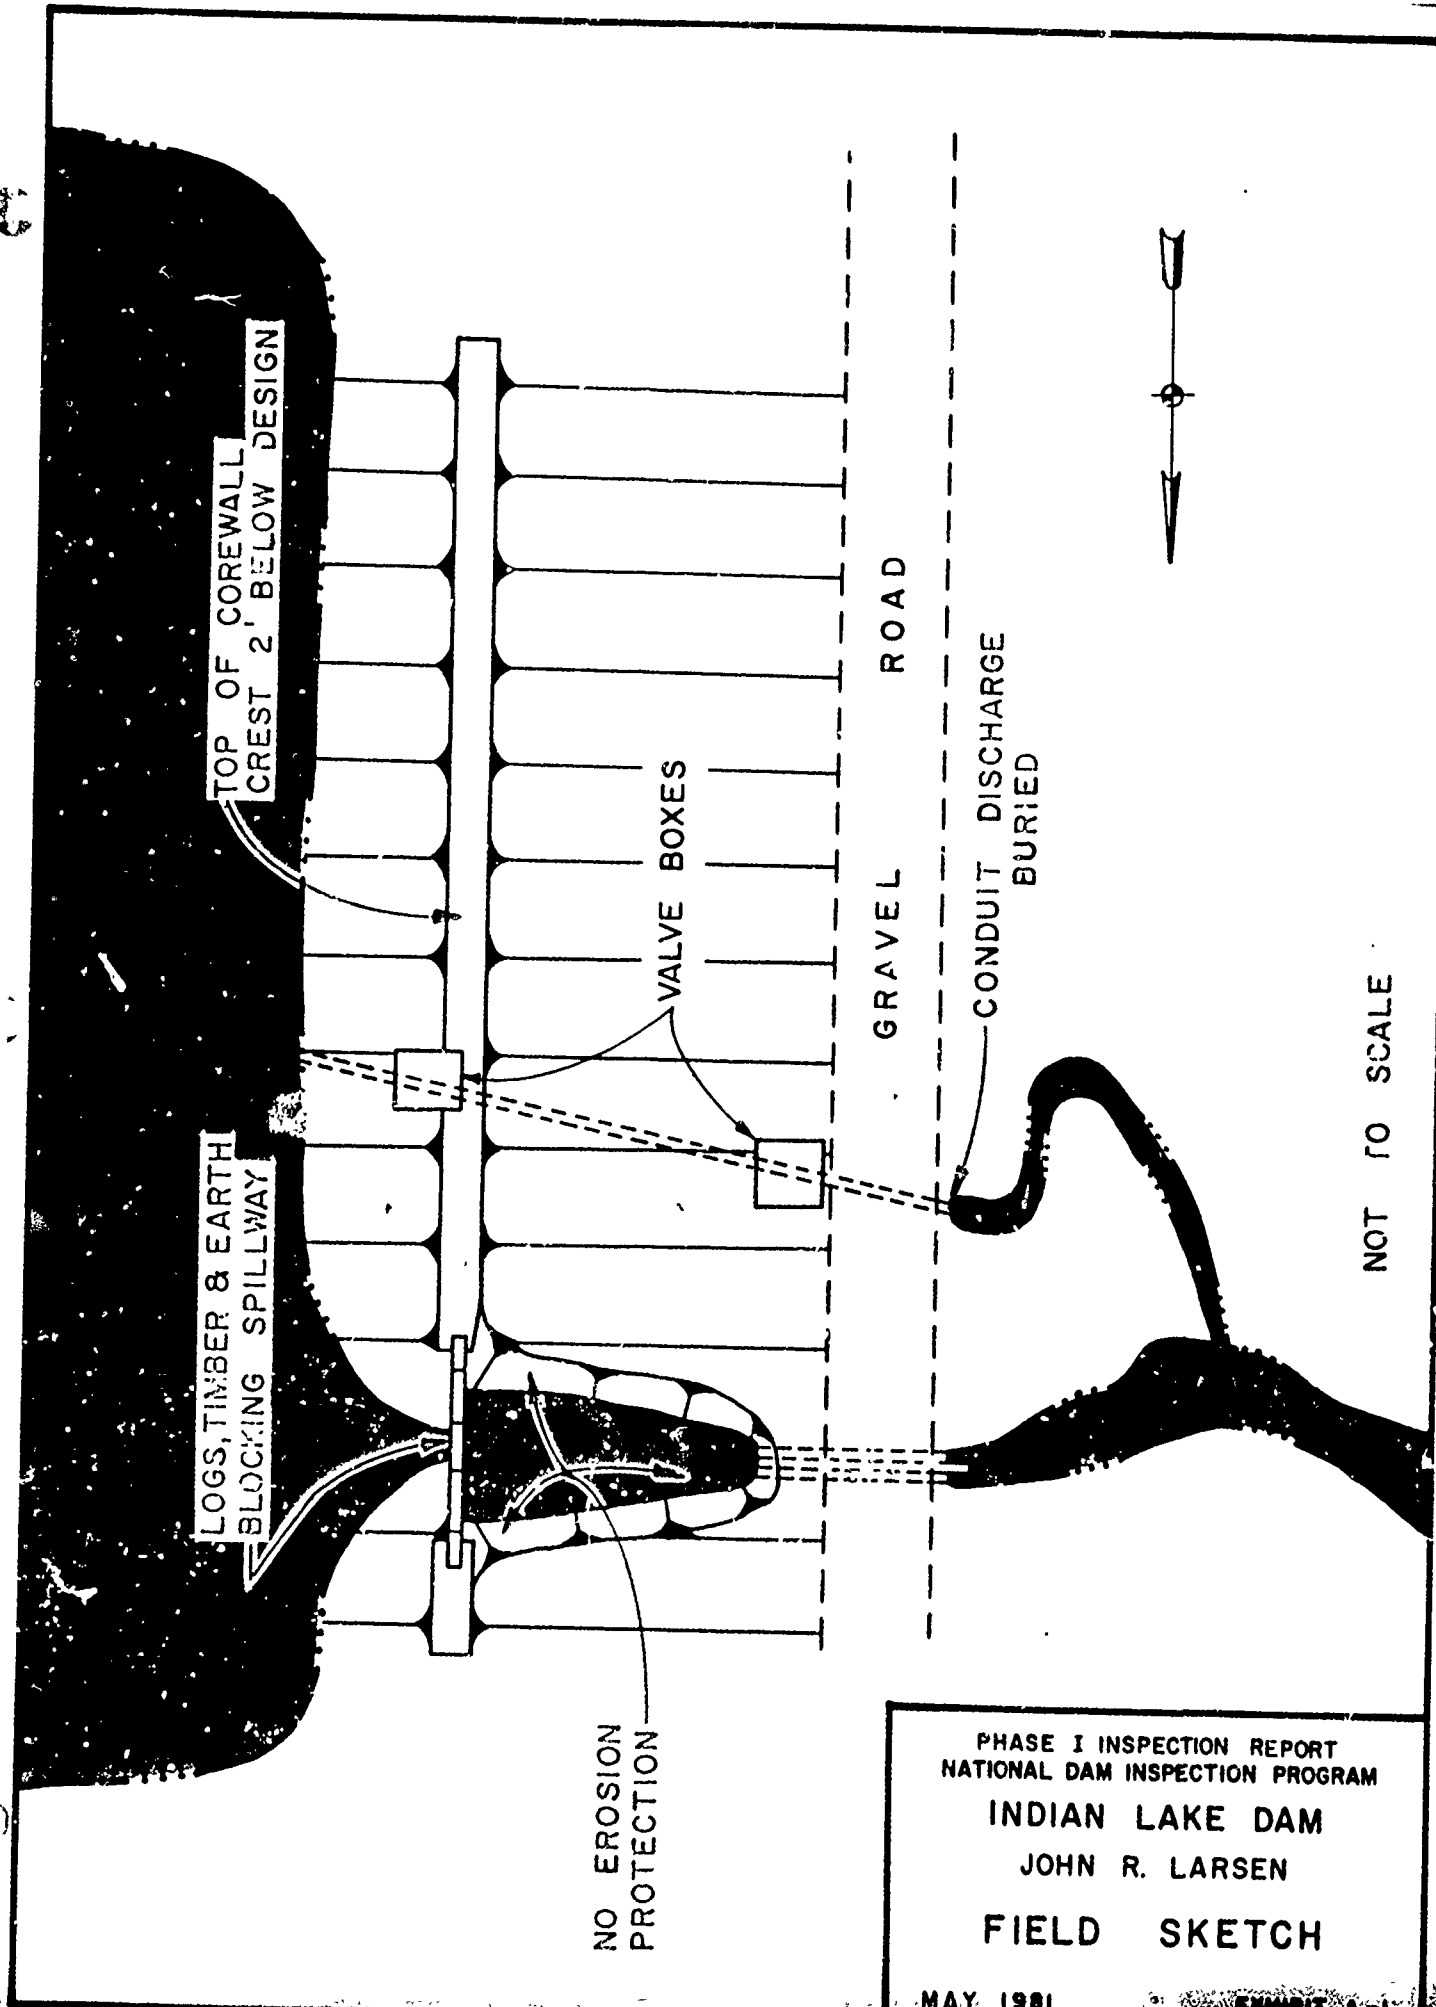
EXHIBIT A-1

On the date of the inspection, a condition was present that may prevent the facility from operating effectively during a flood event. The spillway level has been raised and the top of dam is lower than design. This significantly reduces the freeboard. See field sketch in
